TIGHT IS RIGHT FOR ECU/PPU CABLE

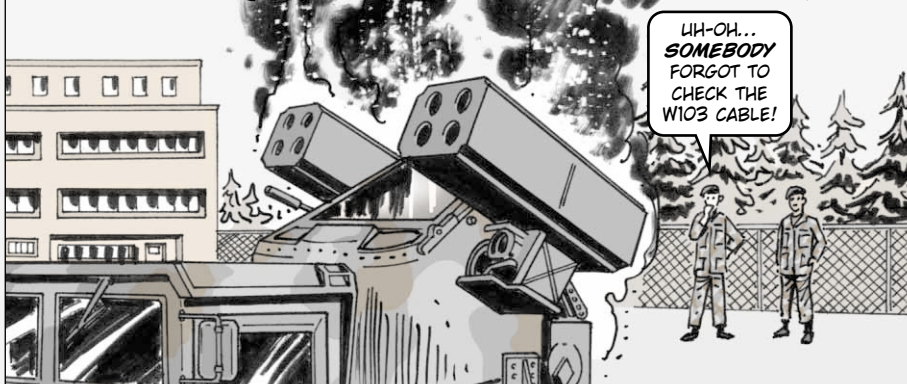
One Avenger cable you don't ever want to work loose is the W103 cable for the environmental control unit/primary power unit (ECU/PPU). The W103 has a shielded ground. If the cable loosens, it arcs and can start a fire. You could be cooked in the turret.

During your before-operation PMCS, check **all** the cables between the ECU and PPU for looseness, but pay special attention to the W103.

Firmly grasp the W103's connector and try to turn it clockwise. If you can move it at all, your repairman needs to tighten it to 95-105 in-lbs. Even if you can't budge the W103, but suspect it might have problems, get your repairman to check it. Better safe than sorry.
